Structural Dilapidation Report

31 Court St, Mudgee NSW 2850

(Our Reference: 36900-SR01_a.docx)

31 Court St, Mudgee NSW 2850 Structural Dilapidation Report

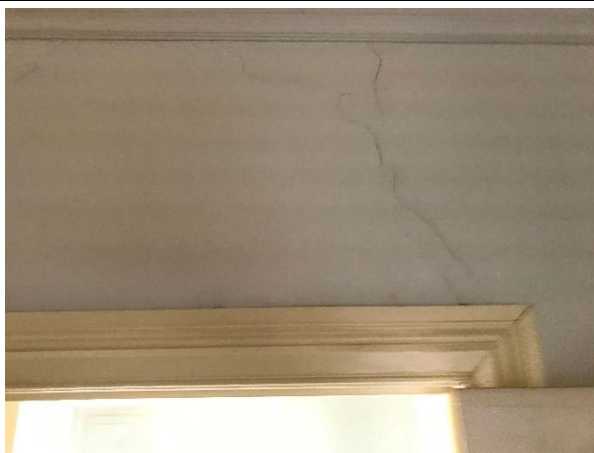
Figure 2 – Cracks in render, 2mm approx. generally throughout

The cause of most of the damage is most likely due to a combination of factors. Mudgee has experienced an unseasonal long dry period and the residence is on moderately to highly reactive clay soils. These soils have dried considerably, experiencing clay shrinkage and causing footing settlement.

The age of the building also means that the footings would not have been constructed to accommodate such seasonally movements and in addition, there are no articulation joints to further minimise the impacts of footing settlement. The rendered walls also are a rigid surface that have little capacity to resist movement. The render has also induced rising damp which in turn, has resulted in mortar failure.

With reference to table C.1 of AS2870:2011 – Residential Slabs and footings (shown below), the damage is classified as ‘moderate to severe’. As such, they pose a serious structural issue currently. The major concerns are the roof hold-down and excessive floor deflection.

- The roof is propped internal with alternate hold-down.
- All internal walls are removed.
- All internal timber flooring is removed.
- The internal masonry skin of all external walls is removed.
- An infill concrete slab is constructed.
- New load bearing timber framed stud walls are installed with suitable hold-down.
- Timber framed stud walls are installed with suitable hold-down to replace the internal masonry skin that was removed.
- Affected mortar is repointed.
- Any additional works as recommended by a rising damp specialist.

Therefore, it is our overall recommendation that the residence be demolished. If you have any further enquiries regarding this matter, please contact the undersigned.

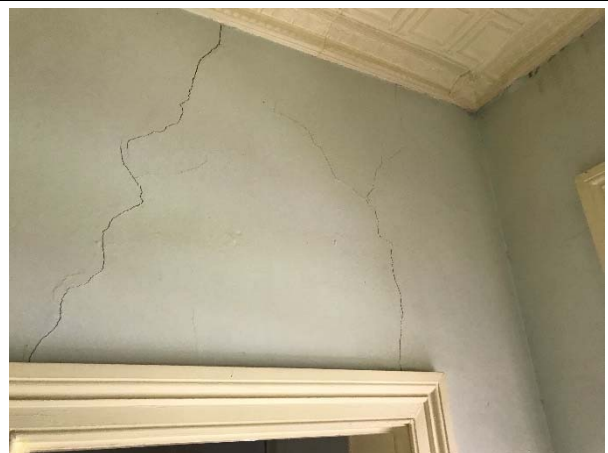
Figure 3 – Cracks in render, 2mm approx. generally throughout

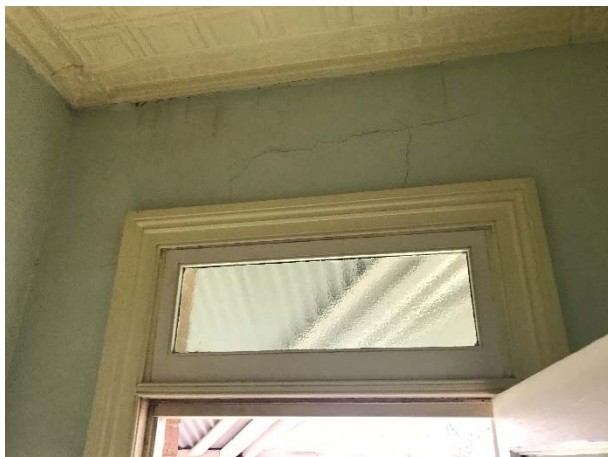
Figure 4 – Cracks in render, 2mm approx. generally throughout

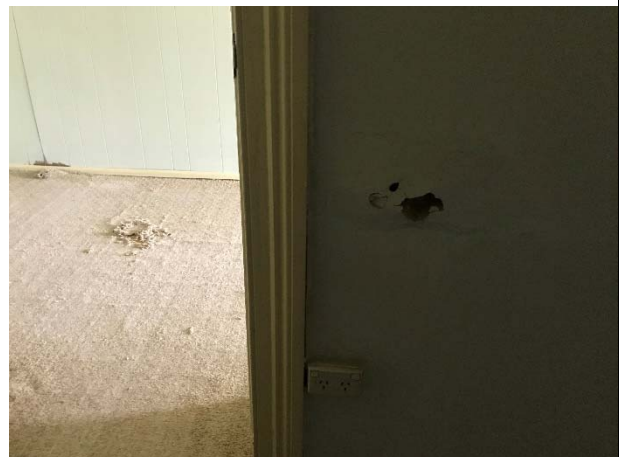
Figure 5 – Spalling render and failed flooring sections throughout

Typically, the roof hold-down would rely on rods embedded into the masonry walls. There is ample evidence of masonry mortar failure to suggest that this hold-down is currently compromised. In addition, there is sever rising dam and excessive deflection in the timber flooring suggesting inadequate ventilation and/or proximity to the natural ground.

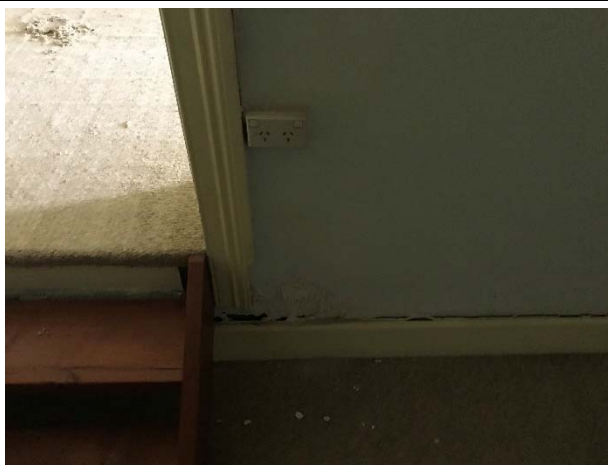
Figure 6 – Spalling render, rising dam, detached skirting and failed flooring sections throughout

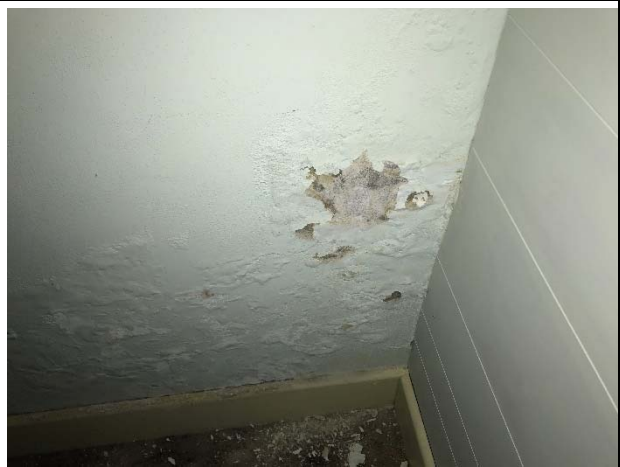
Figure 7 – Spalling render and rising dam, throughout

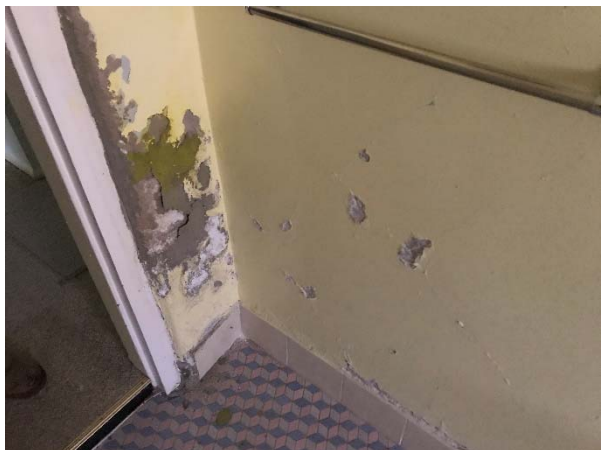
Figure 8 – Spalling render and rising dam, throughout

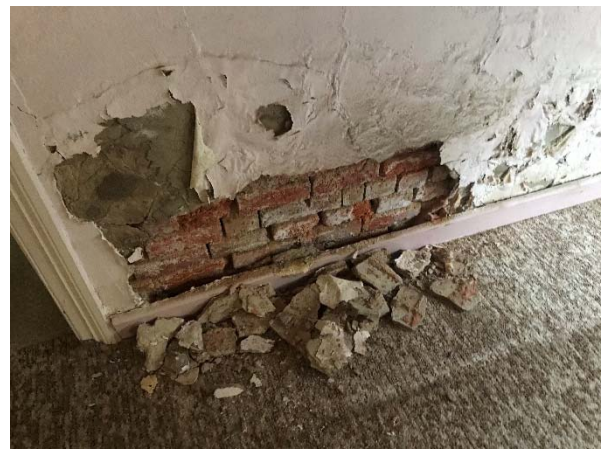
Figure 9 – Spalling render, mortar failure and rising dam, throughout

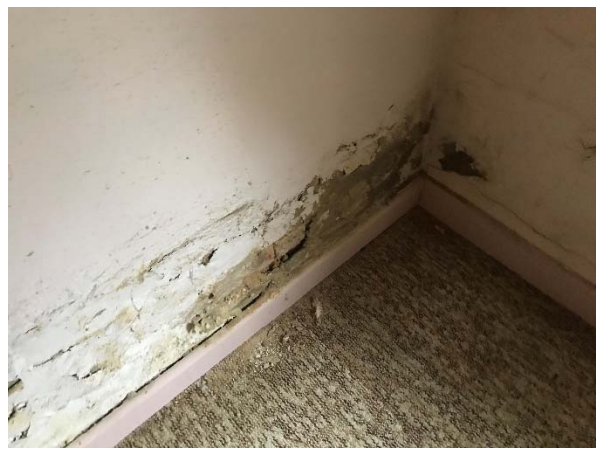
Figure 10 – Spalling render, mortar failure and rising dam, throughout

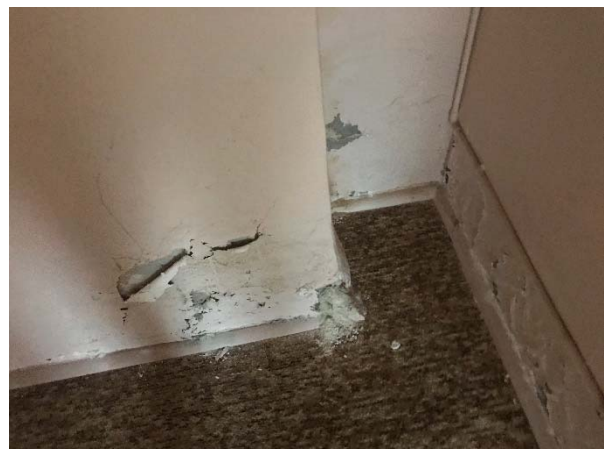
Figure 11 – Spalling render, mortar failure and rising dam, throughout

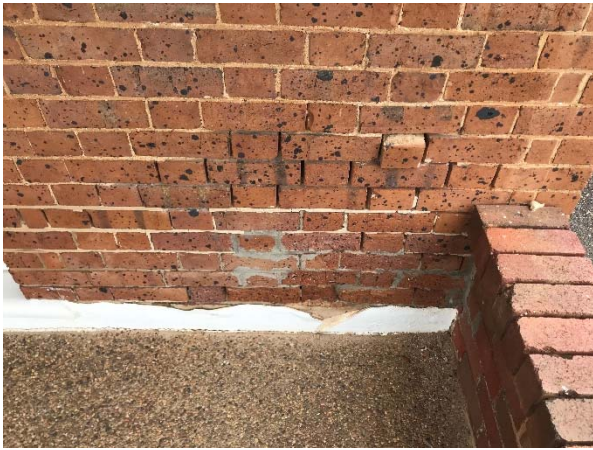
Figure 12 – Rising damp and failed mortar

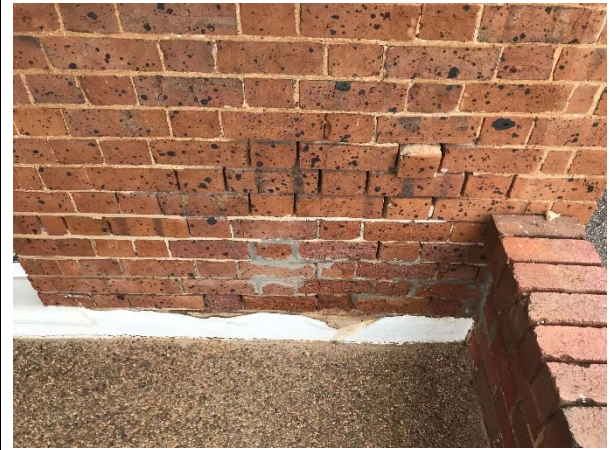
Figure 13 – Rising damp and failed mortar
